# Boulder Creek and St. Vrain Creek Annual Water Quality Analysis for 2017

Prepared for  
Keep It Clean Partnership

Prepared by  
Wright Water Engineers, Inc.

Final Report  
December 2018

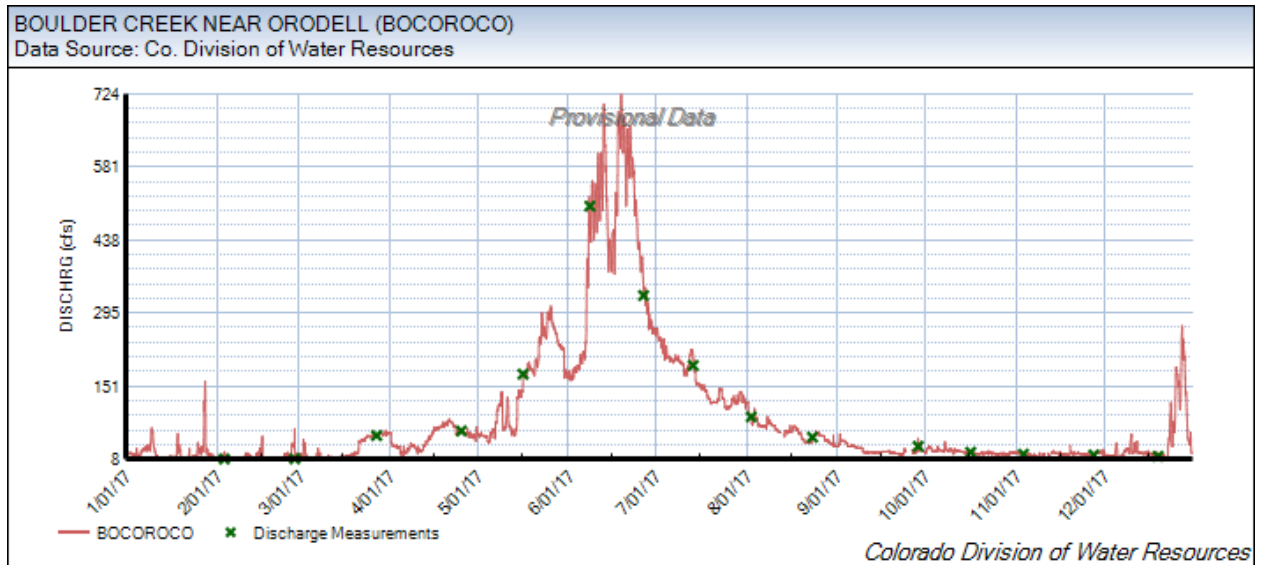
Figure 4. Boulder Creek near Orodell 2017 Hydrograph

During 2017, stream flow was measured at the gauge locations in Table 6. Figure 4 through Figure 12 provide the 2017 hydrographs at these locations, with the format differing slightly depending on whether the site is managed by the USGS, the DWR, or others. Varying periods of record are available for each gauge. A few observations from review of these hydrographs include:

- Spring runoff peaked in late May to mid-June for most streams in each basin.
- Streamflows during 2017 were higher than the historic median during spring runoff for the majority of the basins with available data for comparison.
